National Transportation Safety Board

Safety Recommendation

Pipeline Accident Brief No. DCA93FP004

System Type: Distribution
Accident Type: Explosion and Fire
Location: 634 Cliffwood Avenue, Cliffwood Beach, New Jersey
Date: June 9, 1993
Time: 11:35 a.m. EDT
Owner/Operator: New Jersey Natural Gas Company (NJNG)
Property Damage: \$100,000
Injuries: 3 Fatal
3 Nonfatal
Material Released: Natural Gas
Pressure: 52 psig in main and service line
Type Failure: Crack in pipe adjacent to elbow due to tensile stress
Component Affected: 3/4-inch-diameter inactive bare steel gas service line

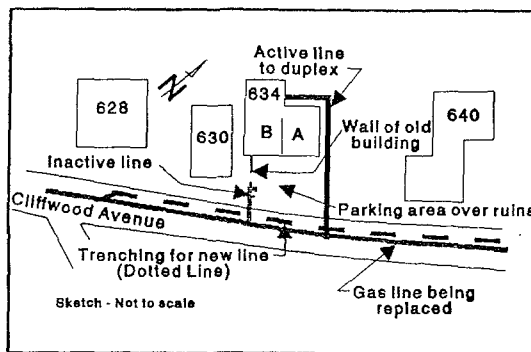
Figure 1. Sketch of the work area.

The NJNG had hired a contractor to replace the bare steel main on Cliffwood Avenue with a plastic main (figure 1). The contract included removing and replacing the service lines to 628 and 630 Cliffwood Avenue with plastic piping. The project did not require that excess flow valves (EFVs) be installed on the new gas service lines.

At 10:30 a.m., while excavating from west to east in front of 634 Cliffwood Avenue, the contractor's trencher hit and punctured a bare steel gas service line that was perpendicular to the street, causing a gas escape. The crew foreman later stated that he had no prior knowledge of any service line to 634 Cliffwood Avenue and was "shocked" to encounter this line.

After pressure-testing the gas main and the punctured service line, an NJNG crew excavated the damaged service line and found that it had a crack where the pipe met an elbow (90-degree turning fitting), about 25 feet from the bare steel main and 21 feet from the facade of 634 Cliffwood Avenue. A Safety Board metallurgist subsequently determined that the fractures on the crack were typical of an overstress separation.

Install excess flow valves on new and renewed single-customer residential high-pressure service lines that have operating conditions compatible with available excess flow valves. (Class II, Priority Action) (P-94-3)

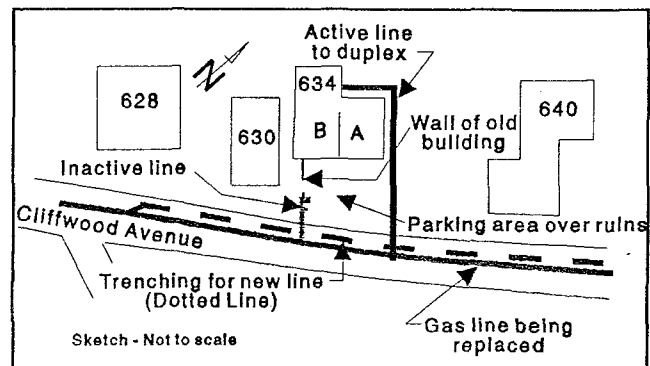
Figure 1. Sketch of the work area.

In 1993, the NJNG hired a contractor to replace the 2-inch-diameter bare steel main on Cliffwood Avenue with a plastic main. The contractor was to lay the 2-inch-diameter plastic main parallel to the street, between the bare steel main and the curb, about 36 feet from the facade of the duplex at 634 Cliffwood Avenue (figure 1). The contract included removing and replacing the bare steel service lines to 628 and 630 Cliffwood Avenue with plastic piping. The project did not require that excess flow valves (EFVs) be installed on the new gas service lines.

At 10:30 a.m., while excavating a 12-inch-wide trench from the west to the east in front of 634 Cliffwood Avenue, the contractor's trencher hit and punctured a 3/4-inch-diameter bare steel gas service line that was perpendicular to the street, causing a gas escape. The crew foreman later stated that he had no prior knowledge of any service line to 634 Cliffwood Avenue and was "shocked" to encounter this line.

After pressure-testing the gas main and the punctured service line, an NJNG crew excavated the damaged service line and found that it had a crack where the pipe met an elbow (90-degree turning fitting), about 25 feet from the high-pressure bare steel gas main and 21 feet from the facade of 634 Cliffwood Avenue. A Safety Board metallurgist subsequently determined that the fractures on the crack were typical of an overstress separation.

Research revealed that the duplex and its parking lot at 634 Cliffwood Avenue had been built over the remains of another building that had been destroyed by fire. Excavation of the accident site revealed that the side foundation wall of the old building, which its gas service line paralleled, ran perpendicular to the street. The gas line servicing the old building entered its foundation at the pipe elbow near the overstress crack. The gas service line was sleeved where it went through the old foundation wall and connected to an unlocked shutoff valve in the off position. In the course of constructing the duplex, the builder flattened and paved over the remains of the old building to serve as a parking lot for the newer building. Paving over debris created voids beneath the pavement. These voids, sealed above by the pavement and to one side by the side foundation wall of the old building, provided a path for the gas to migrate to the duplex at 634 Cliffwood Avenue.

Install excess flow valves on new and renewed single-customer residential high-pressure service lines that have operating conditions compatible with available excess flow valves. (Class II, Priority Action) (P-94-3)
